Structural Assessment Schroon Lake Bandstand

August 10, 2025

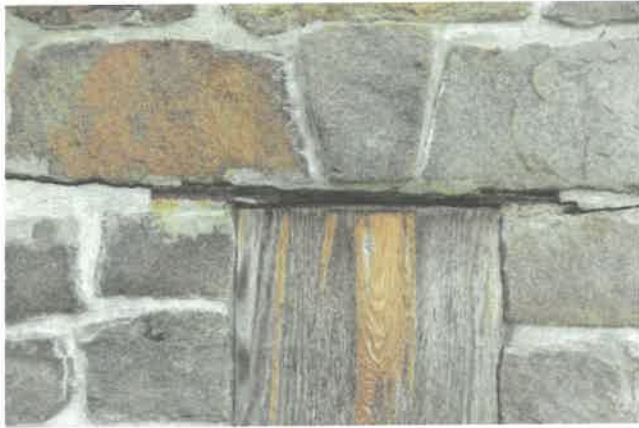
Figure 6 – SW corner of west wall, Bathhouse

- i. There are wall cracks over several openings due to rust jacking caused by corroded lintels and reinforcement. Rusted steel can expand up to nine times its original thickness, causing the mortar joint cracks. The lintels were to be repaired in 1999 to prevent the masonry from cracking further, but that wasn't done. Figures 6-9 show some heavily corroded steel lintels and the resulting wall cracks. Some of the cracks extend above to the concrete edge at the Bandstand level and have cracked that as well.

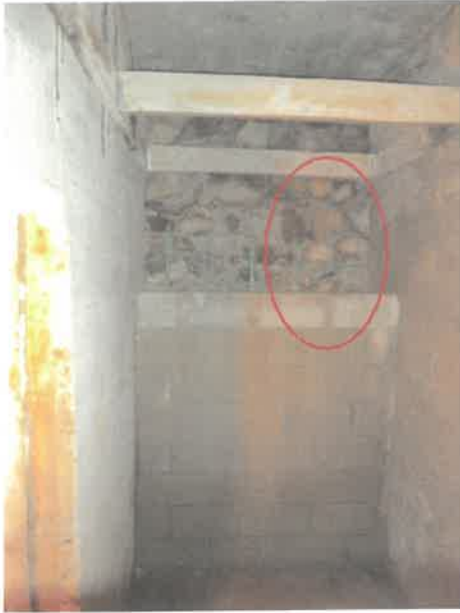
Figure 10 – North bracing wall

There are some masonry and concrete wall cracks in the Bathhouse due to lateral pressure and movement. Two partial walls have been added to strengthen the foundation walls, but the remaining cracks in the walls and the underside of the Park level slab are significant. Figure 10 shows the partial concrete masonry wall that was installed to brace the north foundation wall; another exists at the south wall. Figure 11 shows a close-up of the interior crack in Figure 10 (oval).

- i. As previously noted, two partial-height reinforced concrete masonry walls were added at the NE and SE corners of the Bathhouse level (Figure 10). We could not determine if the NE foundation crack is old or has opened further since the reinforcement was installed.

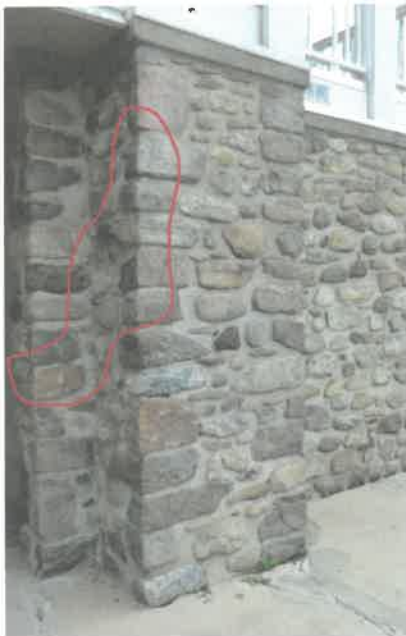
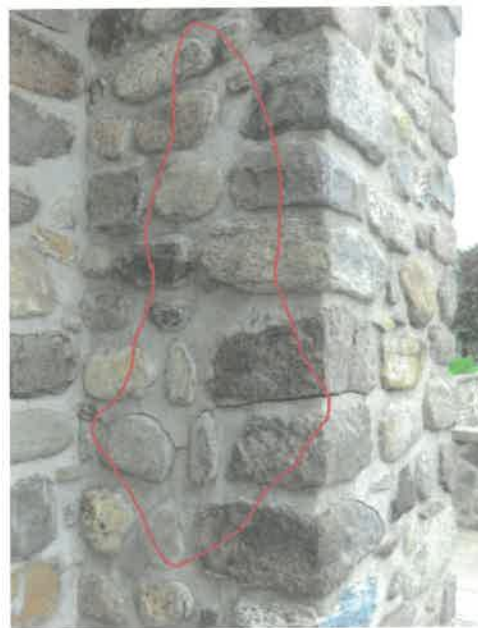
Figure 12 – NW pier at Park level

Wall cracks and debonding at the previous repairs (Figures 12-13). These are the typical cracks that occur throughout the masonry walls. The cracks are likely caused by freeze-thaw effects on the previous repairs.

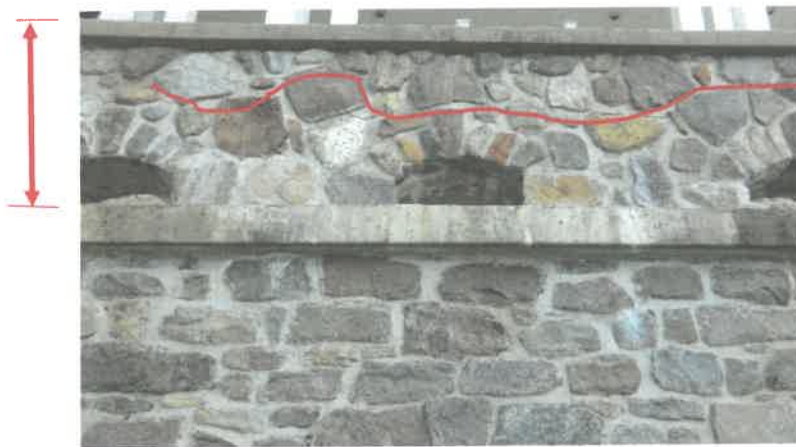
Figure 14 – South railing over Bathhouse

- ii. The Park level has a masonry railing around the perimeter (arrow in Figure 14). Much of this was rebuilt in 1999. The remainder was repointed. There are no floor drains at the Park level. Runoff from the Park Level slab runs out through six arched openings and then drips off the slab. Figure 14 also shows representative cracking over the arched openings on the south wall. The cracking on the exterior is continuous along the south wall and is visible on the Terrace side also (Figure 15). No exterior cracking was evident on the east and west railings that have no arched openings.

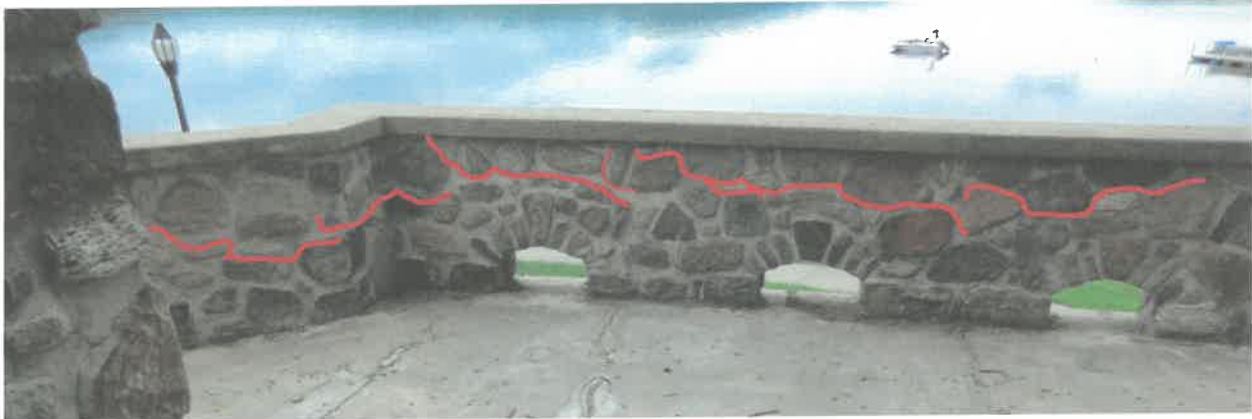
Figure 15 – Cracking at the south elevation railing

The interior side of the railing has cracking like the exterior. Figure 15 shows a portion of the south elevation. There is minimal cracking on the interior of the east and west walls where there are no arched openings.

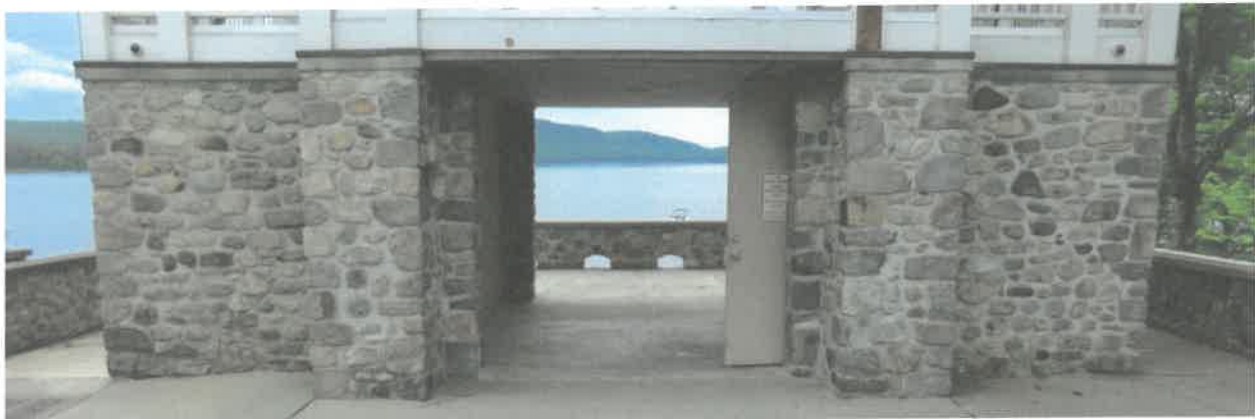
Figure 18 – 2025 Photograph

Figure 18 is a recent photograph. Much of the stone, except at the corners, is rounded, uncoursed, and has some larger joints. These are likely changes made in 1999.

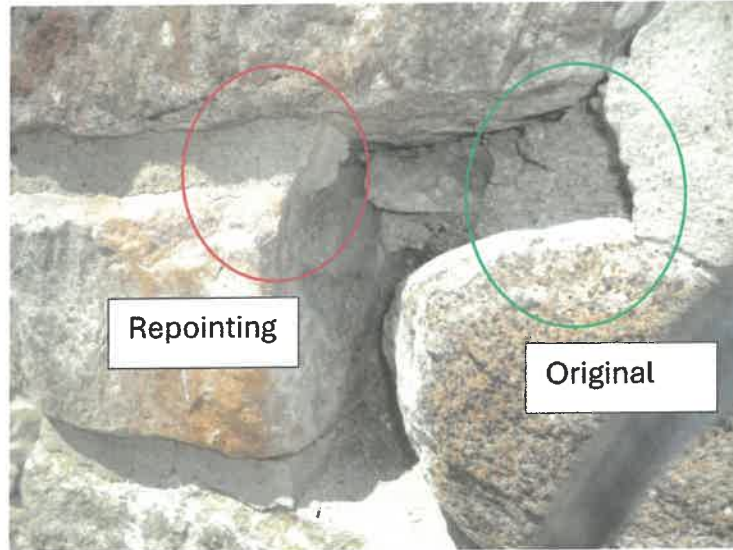
Figure 19 – Southwest pier with 1999 repointing and original mortars visible

iv. There is missing mortar in the southwest pier (Figure 19). The 1999 repointing mortar is visible as well as the original mortar inside. The repointing mortar did not bond to the stones well, and the joint cracked.

Samples of the mortar were tested qualitatively using acid digestion. The original mortar is a combination of Portland cement, lime, and aggregates. I estimate equal proportions of Portland cement and lime. The repointing mortar had mostly Portland cement and little lime. The repointing mortar is probably 50% to 100% stronger than the original mortar. This differential might be a factor in the cracking we see throughout the walls.

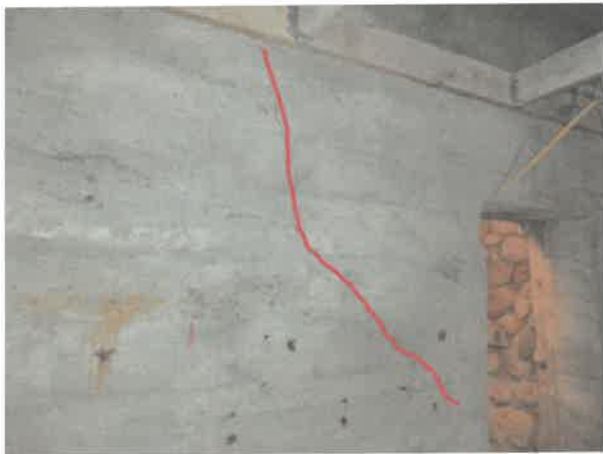
Figure 20 – Interior wall crack

An interior concrete wall is also badly cracked (Figure 20). The crack extends through the Park Level slab above (Figure 21). This cracking is likely from the earth pressure on the north wall.

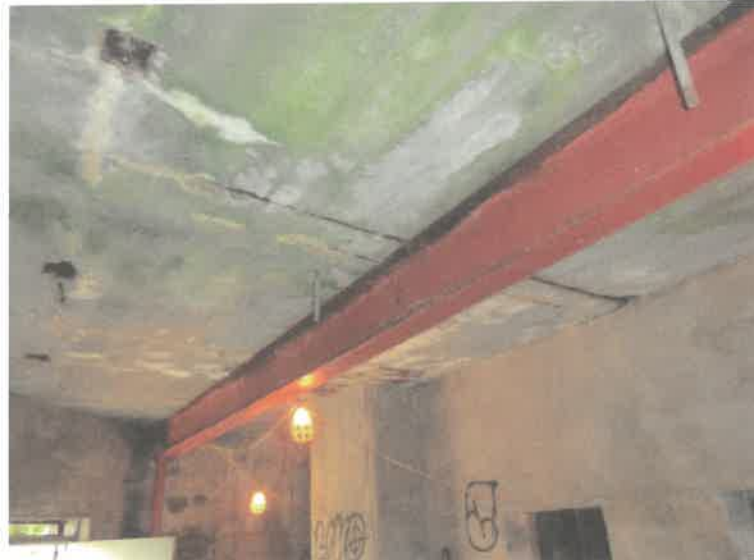
Figure 22- Bathhouse ceiling

- ii. The underside of the Park level slab has 14 cracks that align with cracks on the top of the slab (Figure 22). In this one photograph, we see:
- Corroded reinforcing bars.
 - Corroded structural steel supports.
 - Cracks around embedded electrical boxes.
 - Evidence of water leaks from above.

The steel framing was installed in 1999, likely as a reaction to the cracks. In 2007, the framing was to be removed, repaired, and reinstalled. There is no evidence that was done.

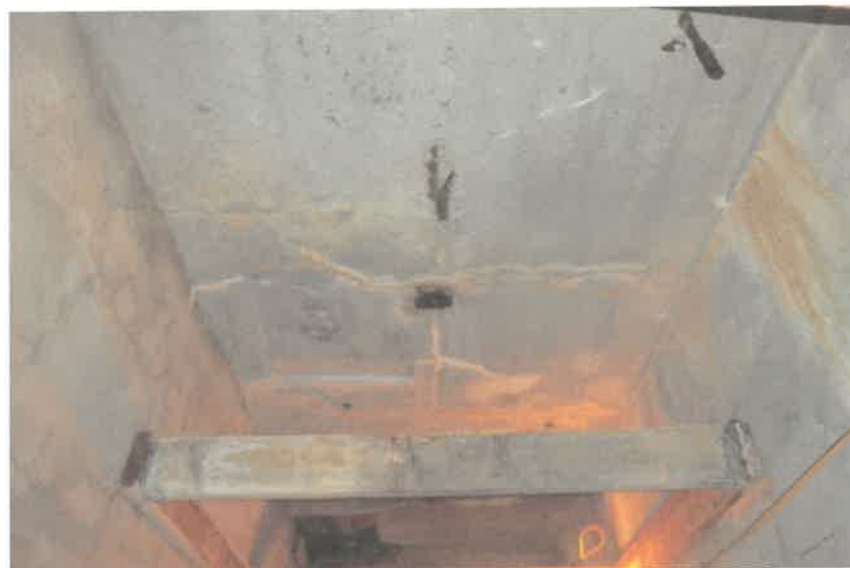
Figure 23 – Bathhouse ceiling

Figure 23 shows another example of cracking and spalling of embedded reinforcement and an electrical box. The light-colored material at the cracks is due to the water leaking through the concrete.

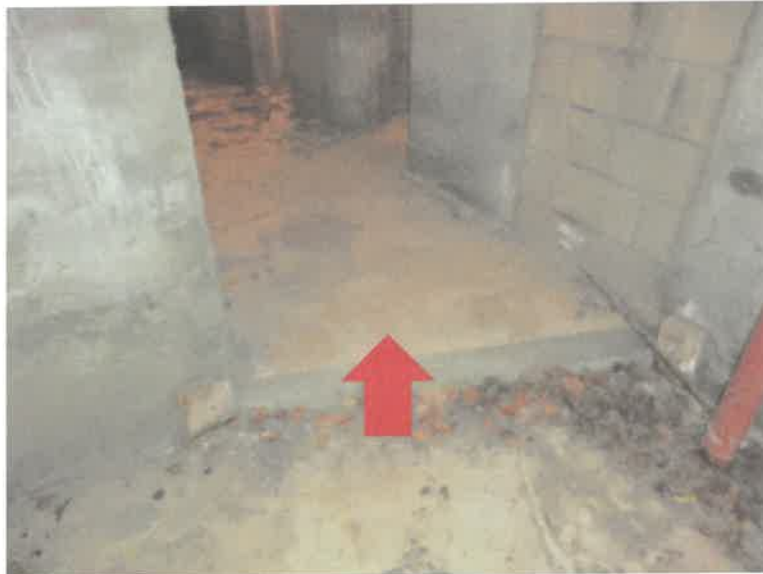
Figure 24 – Overpoured concrete floor

Bathroom level, an overpour of concrete was made (Figure 24, arrow). The reason for this is unclear; it may have covered a cracked floor.

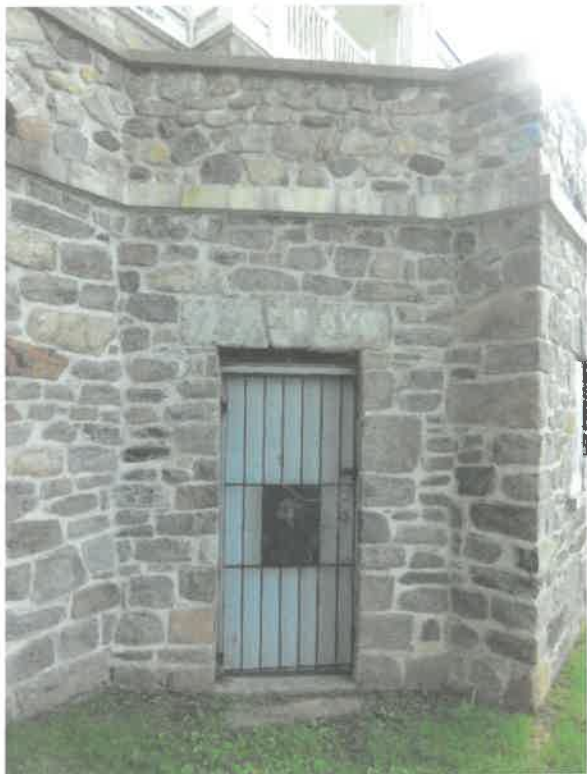
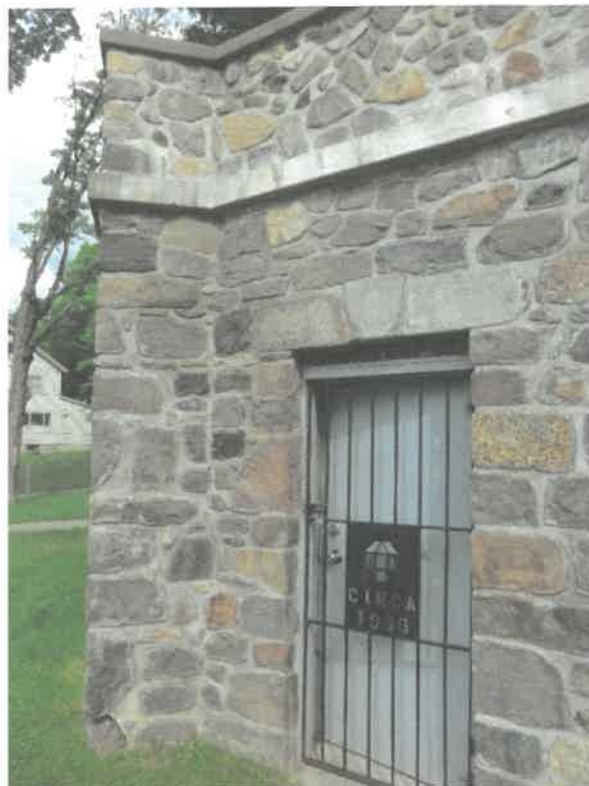
- iv. The exterior metal doors are rusted and don't close (Figures 26 and 27). They are screwed shut when not being used. "BOYS" is painted over the west door, and "GIRLS" on the east door, and are faintly visible. There are ornamental door gates on the exterior of both doors. These were not mentioned in any notes from 1999 or 2007.

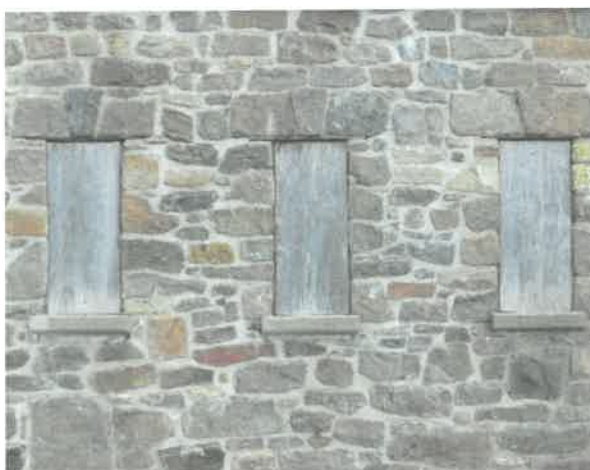
Figure 28- Covered windows, North wall

- v. The eight windows at this level have been covered with plywood (Figure 28). The original drawings indicated the windows were wire glass. These covers also appeared in a photograph from 1999. The windows were proposed to be infilled with masonry in 1999, but glass block was installed instead. About 50% of the glass blocks are broken. The intact glass blocks could be used as extras for the Park level windows.

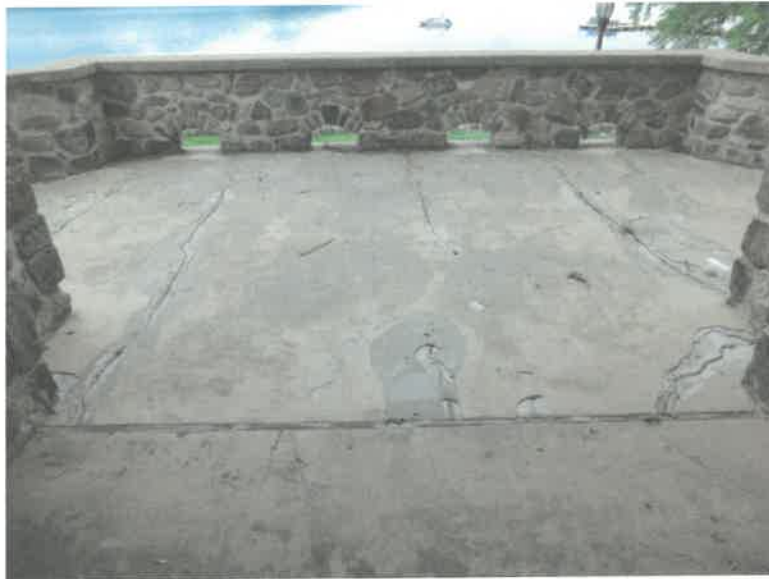
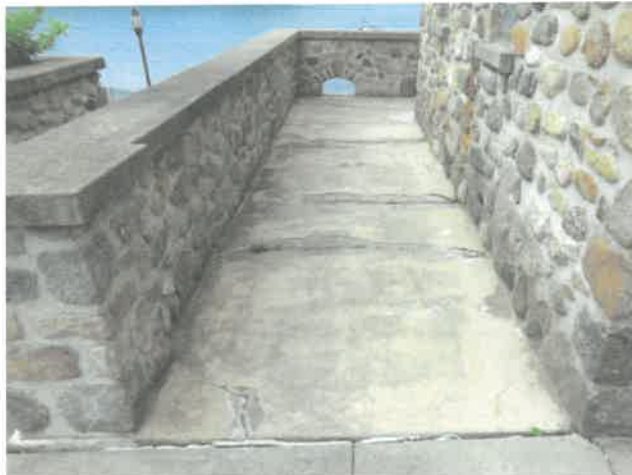
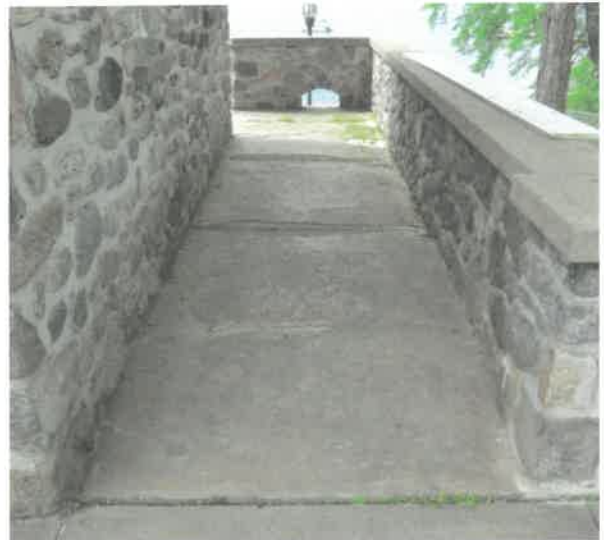
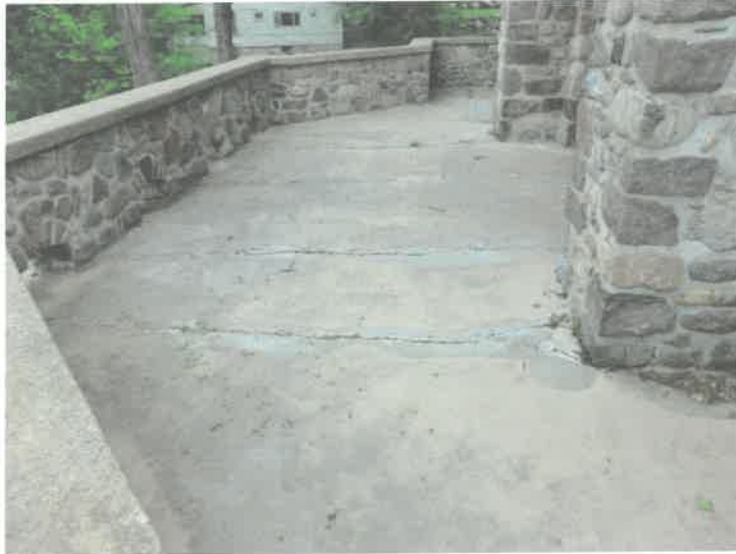
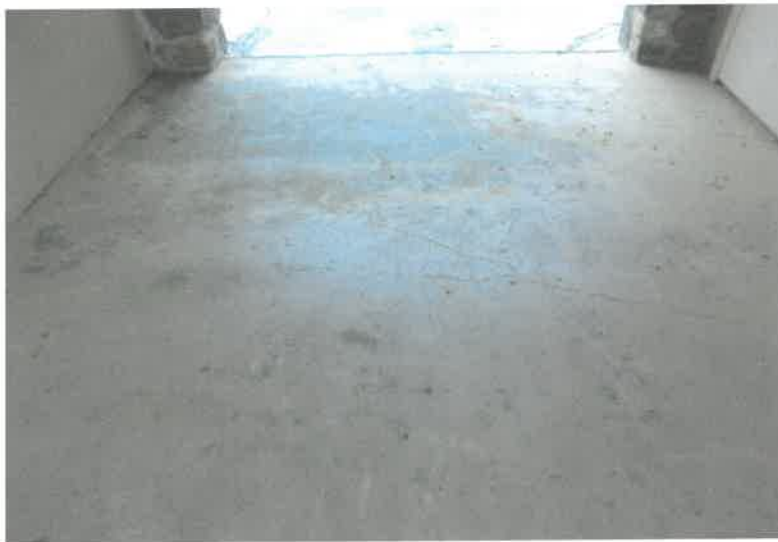
- i. The concrete slab was patched and coated in 1999. The 2007 design specified replacing the entire slab; this was not done. Figures 29-33 show the many cracks and the peeling coating that was probably installed in 1999. The cracks create trip hazards and allow leaking below.

- v. The Park level concrete slab has numerous cracks and deterioration, with the area within the building being in fair condition and the exterior areas of the walkways and Terrace being in very poor condition.

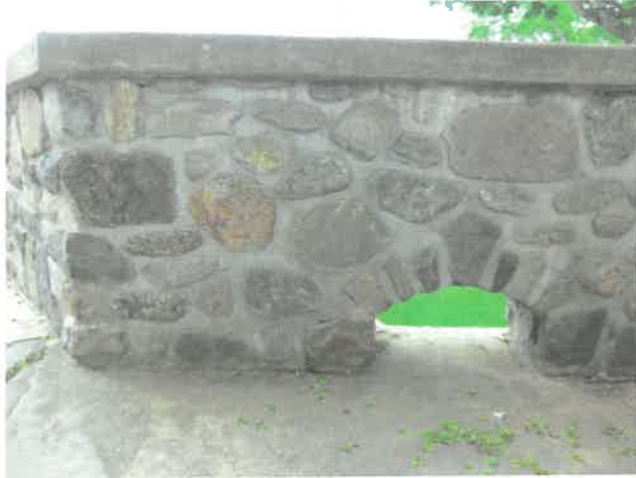
Figure 34 - Drainage opening for Park level slab

- ii. There are no floor drains at the Park level. The Terrace water is intended to drain to the wall openings in Figures 29-31. Figure 34 shows a typical opening at the south.

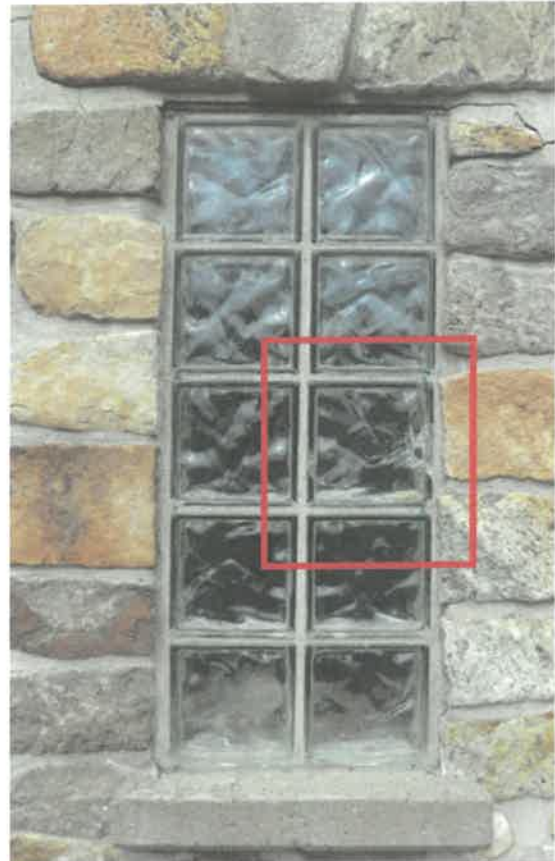
Figure 37 – East wall, broken glass block

- v. The four windows at this level (two on the east and two on the west) have glass blocks like was used at the Bathhouse windows. These appeared covered in a photograph from 1999 (Figure 36) and were proposed to be infilled with masonry. There are a couple of broken glass blocks on the East wall (Figure 37). Intact blocks from the bathhouse level could be used to replace these, and the jambs can be rebuilt.

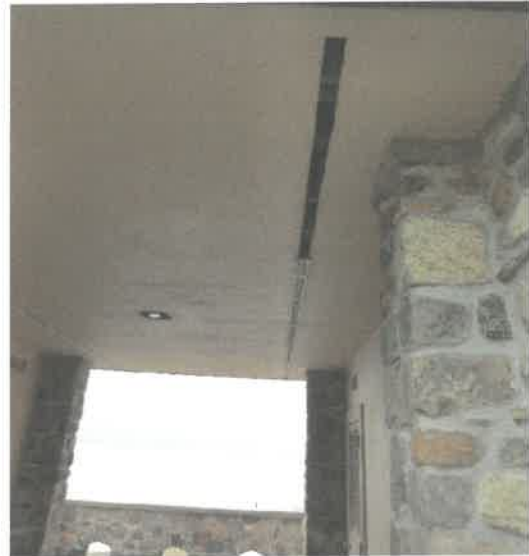
Figure 40 – Missing and damaged vent

vii. The wall covering and the ceiling for the “tunnel” were installed in 1999 (Figure 39 and are generally in good condition. Additional vents were proposed in 2007 but were not installed, and there appears to be no need for them. There has been damage to a portion of the vents (Figure 40). We did not have access above the ceiling to check the framing. The flooring above needs to be removed to check it.

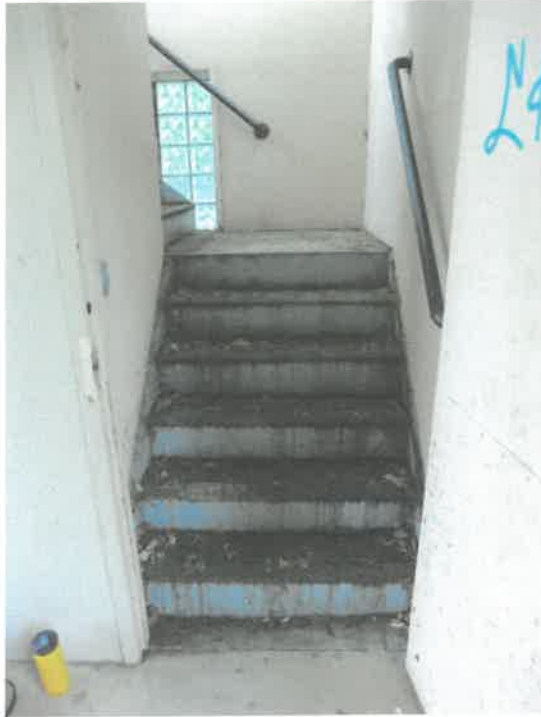
Figure 41 – Stair from Park level

viii. The stairs to the Bandstand level were replaced in 1999 (Figures 41-43). They were to be removed, repaired, and reinstalled in 2007, but that did not occur. The Bandstand level opening allows rain, snow, leaves, birds, etc. to enter. There is no drainage; the water sits on the stairs and runs to the Park level. Figure 43 shows the corroded stair framing.

The stairs will be a forever maintenance issue until the stair opening can be modified to prevent water entry when not in use.

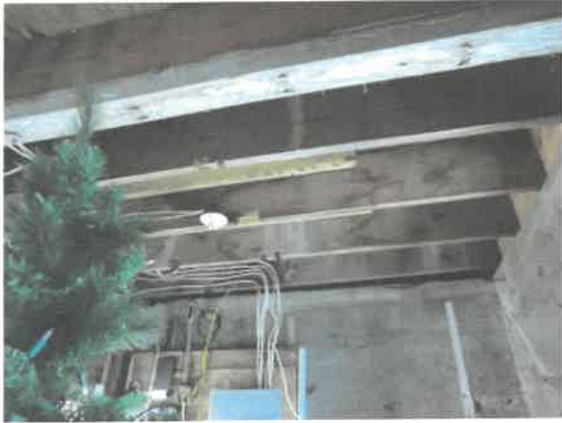
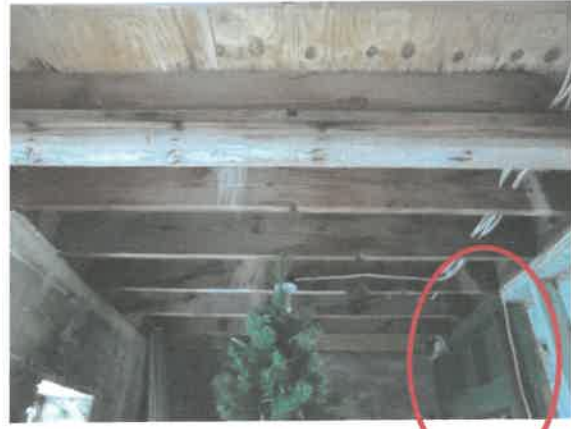
Figure 44 – East room with electrical and storage

Figure 44 shows two views of the Bandstand structure above the electrical room. Several of the joists have been notched over the years without being strengthened; these can be repaired.

The green framing at the lower right (oval) is the infill framing for the previous door. The exterior walls are covered with concrete parging over the stone walls. There are cracks throughout.

The ceiling framing shows some water stains, but no active leaks were noticed.

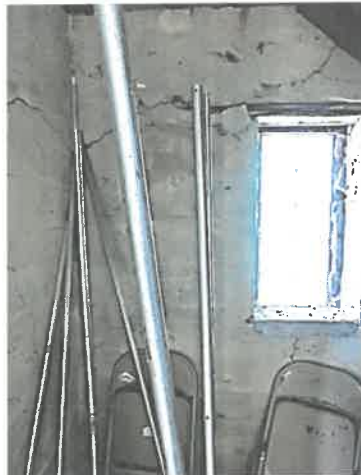
Figure 45 – West room, west wall

- ix. Figure 45 shows a window on the West wall of the west room. The interior surface of the exterior walls is coated in a cement plaster, like the Bathhouse walls. The horizontal crack from the left corner of the window goes to the corner and continues along the south wall. This crack is through the entire wall and is visible on the exterior. The lintel rust jacking has damaged the whole thickness of the wall.

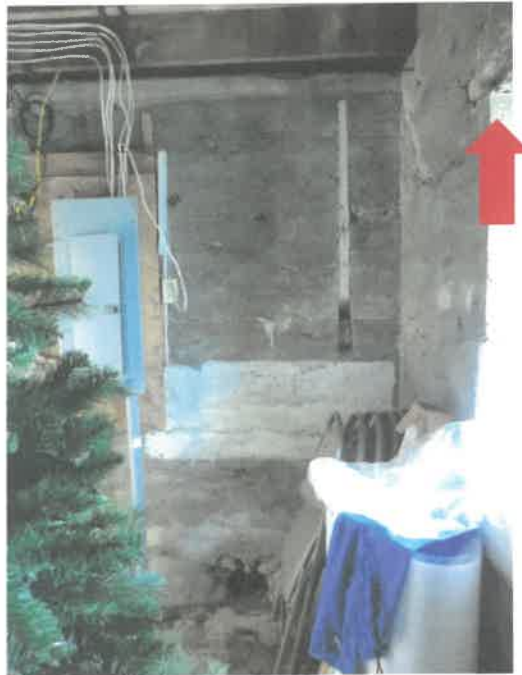
Figure 46 – North wall of Electrical room

Figure 46 was taken from the electrical room of the east room and shows corroded reinforcement protruding from the interior plaster over the stone wall.

The corroded lintel is visible just over the glass block window (arrow), and the cracks travel to the north wall.

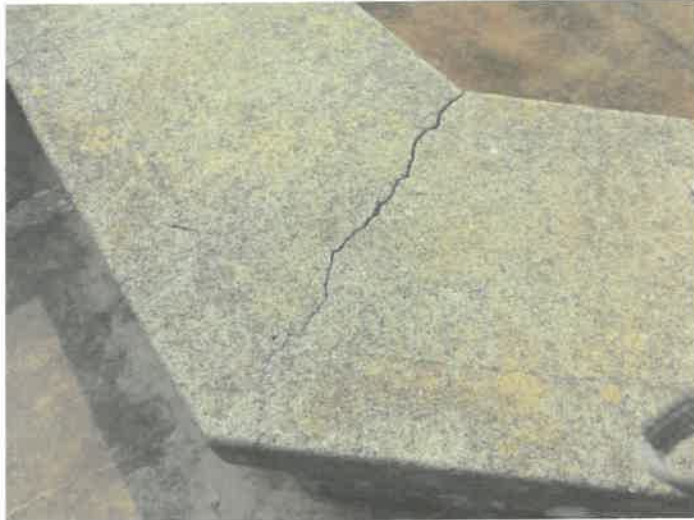
Figure 48 – Corner crack in Terrace railing

There are shrinkage cracks along the entire railing cap. Figure 48 shows one of the larger cracks. Figure 49 shows a more typical crack. It seems there were pins placed in the cap on the stone wall below. These acted as restraints to the shrinkage. The cracks are repairable.

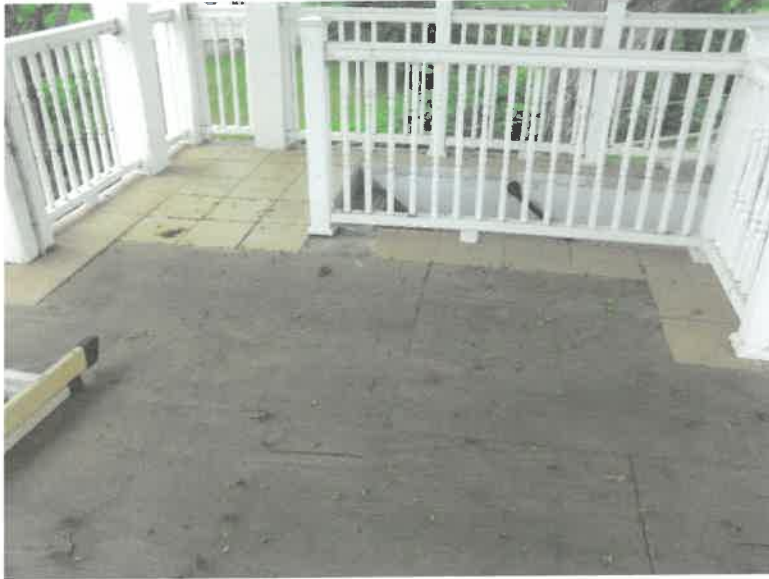
Figure 50 – West end including stairs

- i. The wood deck is exposed and water-damaged (Figures 50-52). Originally, the deck was canvas-covered and painted. At some point, edge tile was added. Previous projects had proposed installing either vinyl flooring or fiberglass. Surprisingly, there isn't water damage to the ceiling below or to the side rooms (except at the stairs) where there is no ceiling.

- ii. The opening for the stairs (Figure 50) to the Park level allows snow and water onto the stairs, causing the deterioration. The stairs were replaced at least once before.
- iii. Figure 53 shows the railing configuration from the original drawings.

In both 1999 and 2007, the railing was recommended to be replaced with an aluminum railing. At some point, it was replaced with plastic, not aluminum. It does not match the original design, and it is not safe, particularly at the stair opening (Figure 50).

- iii. Bandstand stair opening is a continual problem, allowing water to damage the stairs and doorway below. It should have a removable cover.
- iv. The Bandstand railing is unsafe and needs replacement. The original design should be reinstated for aesthetics.

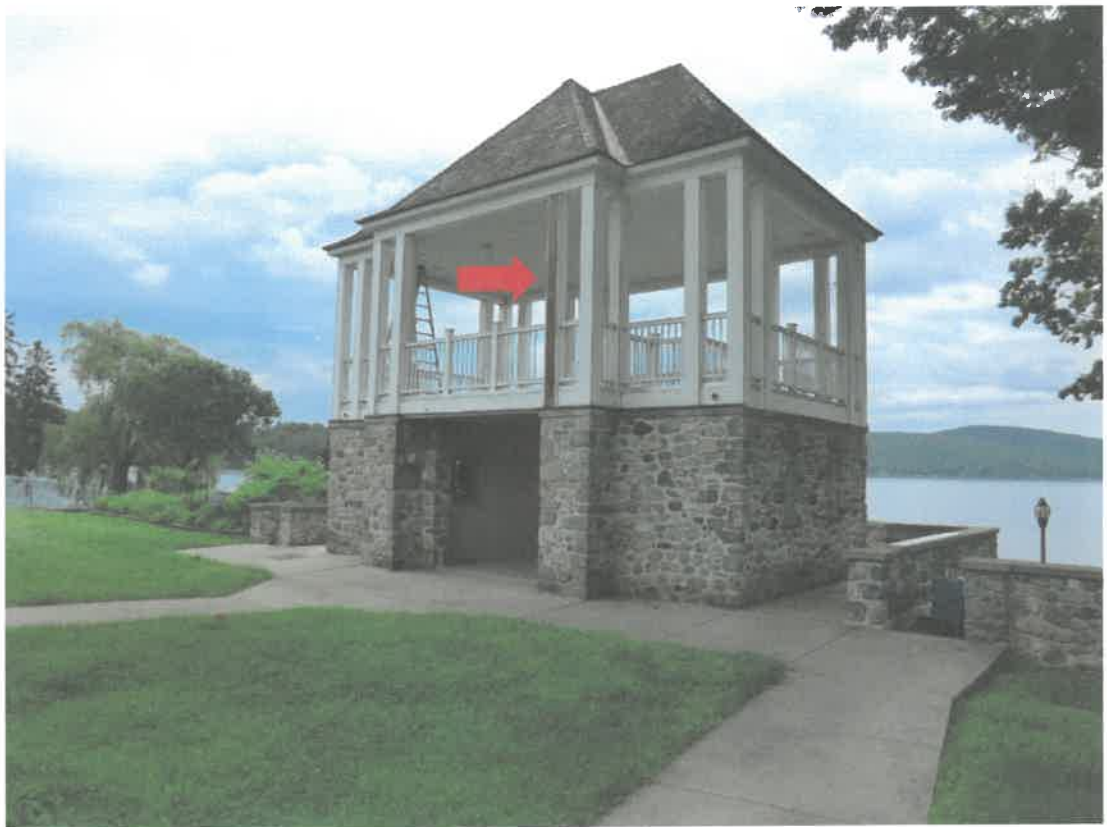
Figure 55 – Column post cover removed on a north column

Ethan Thompson and crew removed one of the column post covers (Figure 55, arrow). Figure 56 shows the 2007 detail, which had a 2-inch wide 24-inch-long strap. There was no strap connector found (Figure 57).

No connectors were visible on the bottom, but to have seen them as detailed would have required removing a portion of the flooring and tile.

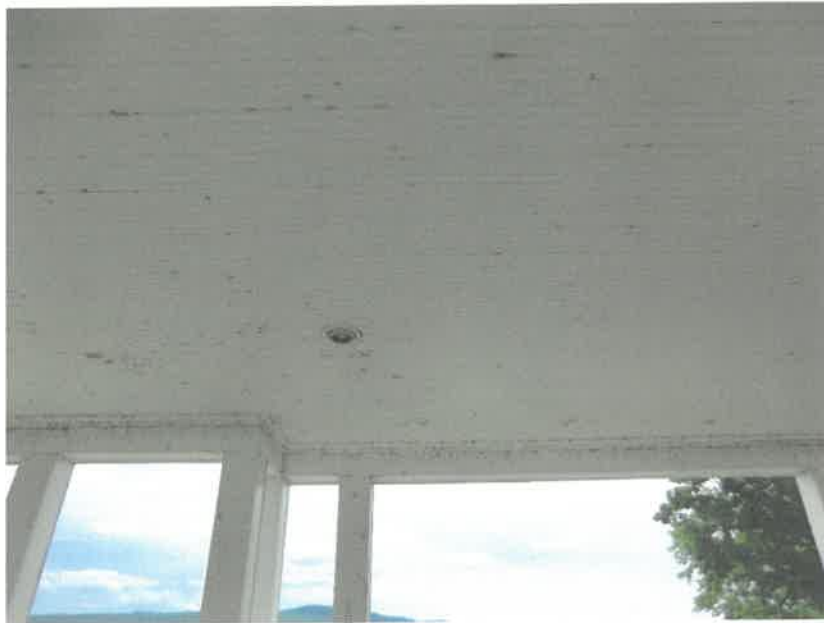
Figure 59- Bandstand ceiling with insects

- vi. The ceiling and columns appear in generally good condition except for an insect infestation (Figure 59).

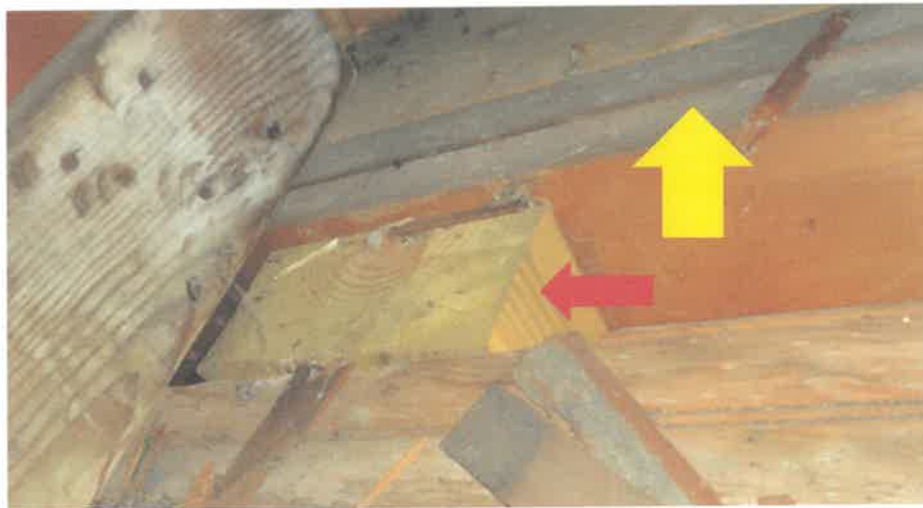
Figure 62 – Top of wood posts in the attic

From inside the attic, the notched top of a new column was visible as well as the original 2 -2x10 roof beams (red arrow and yellow arrow respectively (Figure 62). Thus, the 2007 proposed beams were not added. We agree they should be added as shown on Figure 61.

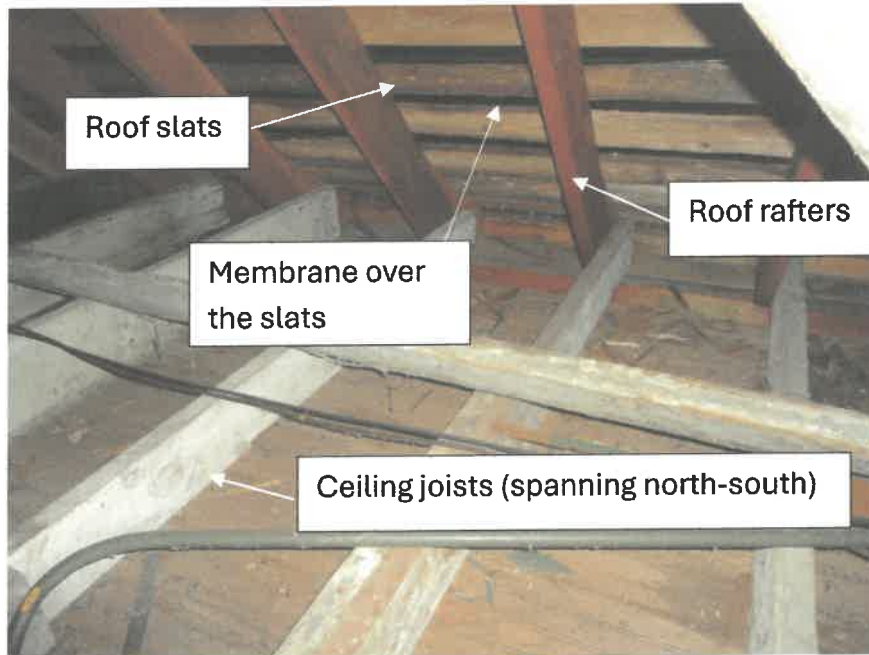
Figure 70 – Attic framing

Viewed from the interior, the wood shingles are supported on wood slats over a black membrane (Figure 70). The membrane provides waterproofing; however, it may not allow ventilation of the shingles. In addition, there are no soffit or ridge vents on the roof.

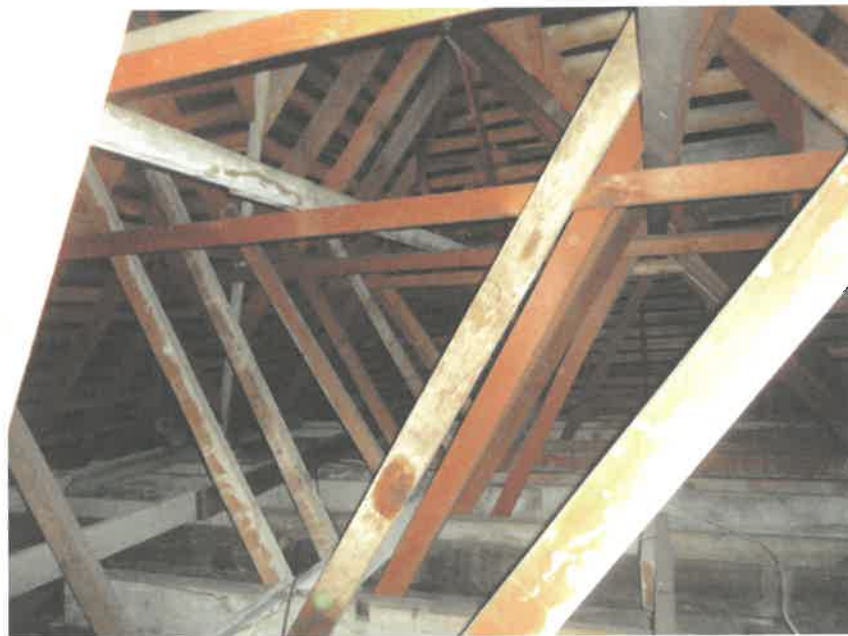
Figure 71 – Attic framing

- iv. The roof framing appears in good condition and is well-braced. (Figure 71). A few joists have been notched for running electrical lines, which weakens the wood, but that can be corrected. There is no evidence of distress.

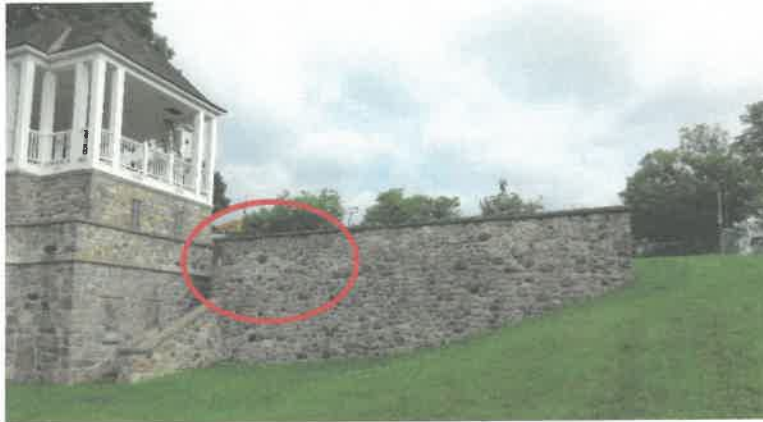
Figure 72 – East retaining wall showing efflorescence.

- i. The retaining walls are also stone masonry. They were fully repointed in 1999. They remain generally in good condition.
- ii. Figure 72 shows white efflorescence on the east wall. This is salt staining, likely due to water penetration from the garden side, dissolving the mortar.

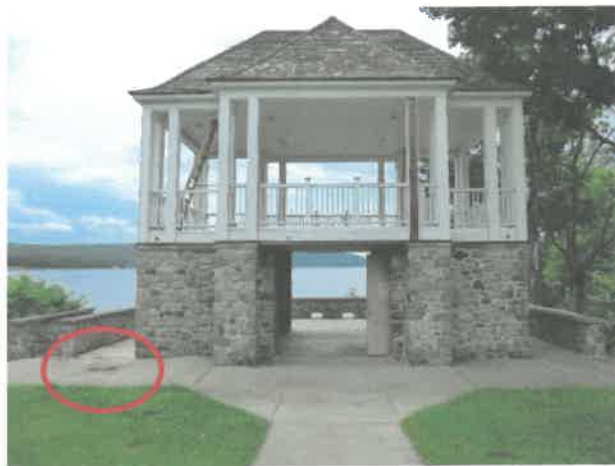
Figure 73 – Shows the catch basin

- iii. There is a catch basin on the northeast corner of the building (Figure 73). It is filled with grass cuttings and soil and does not drain. This needs to be corrected.

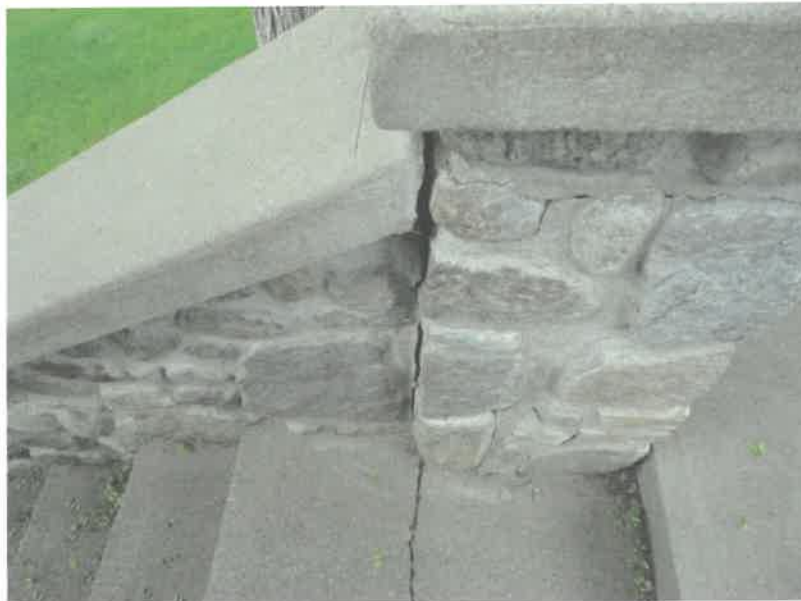
Figure 76 – West stair separation

- iv. The stairs to the Bathhouse level on the east and west were replaced in 1999 (Figures 74-76). Figure 76 shows a minor crack and separation at the west wall.
