Watershed Management Plan

2010

SCHROON LAKE WATERSHED MANAGEMENT PLAN

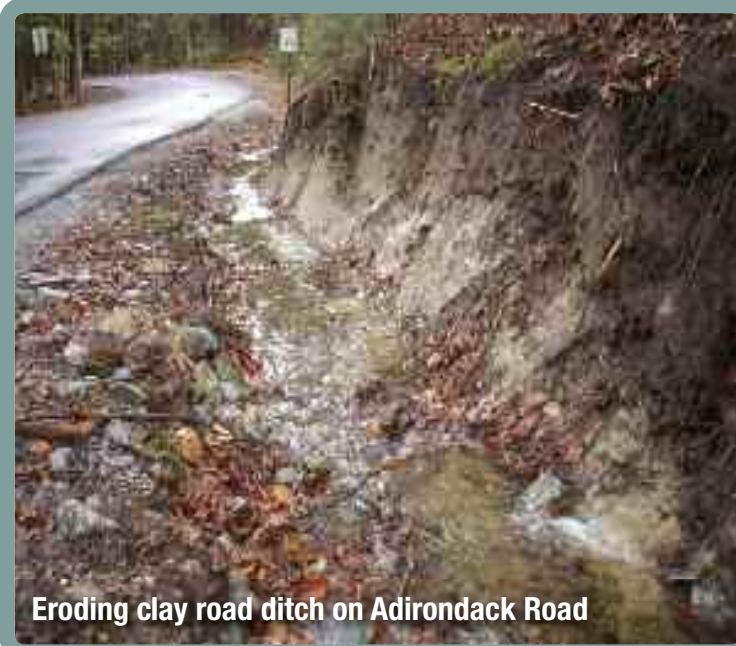
Eroding clay road ditch on Adirondack Road

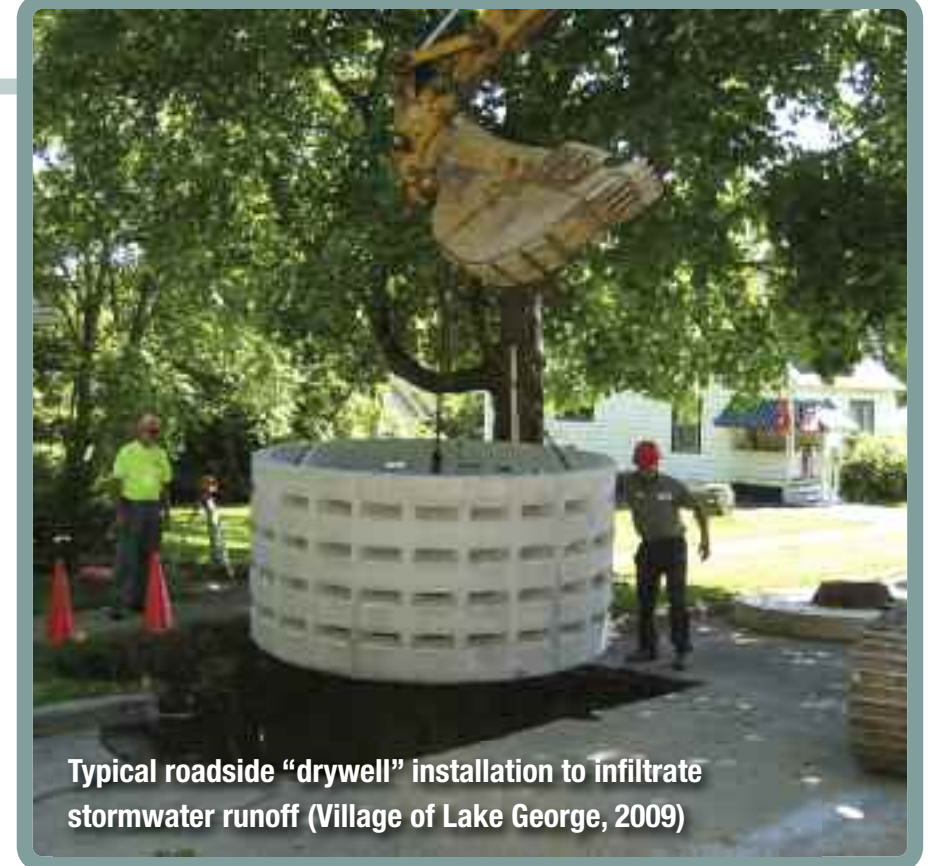
Typical roadside "drywell" installation to infiltrate stormwater runoff (Village of Lake George, 2009)

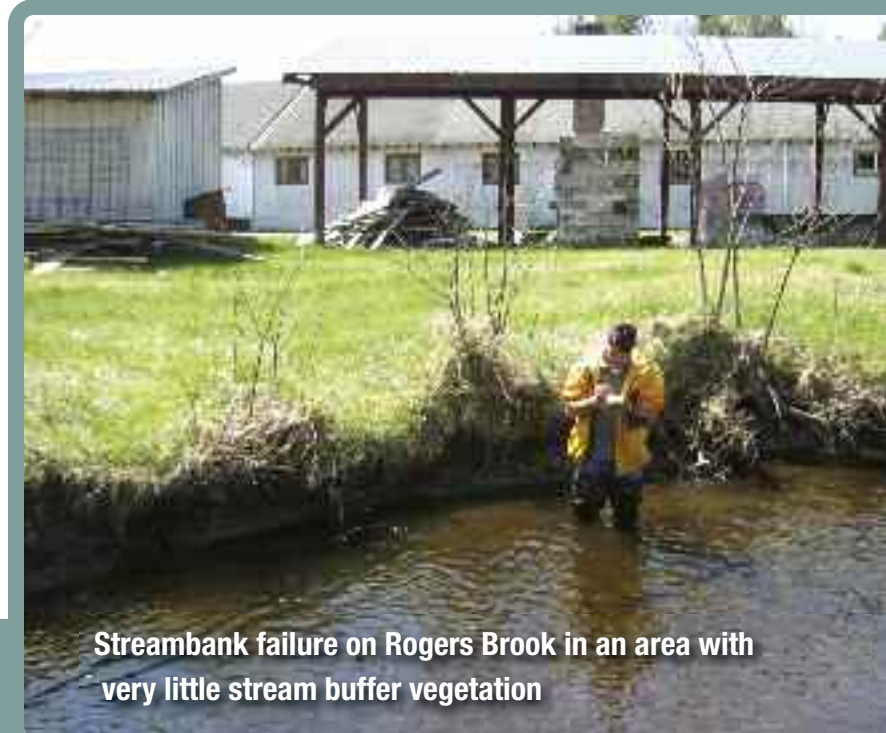
Streambank failure on Rogers Brook in an area with very little stream buffer vegetation

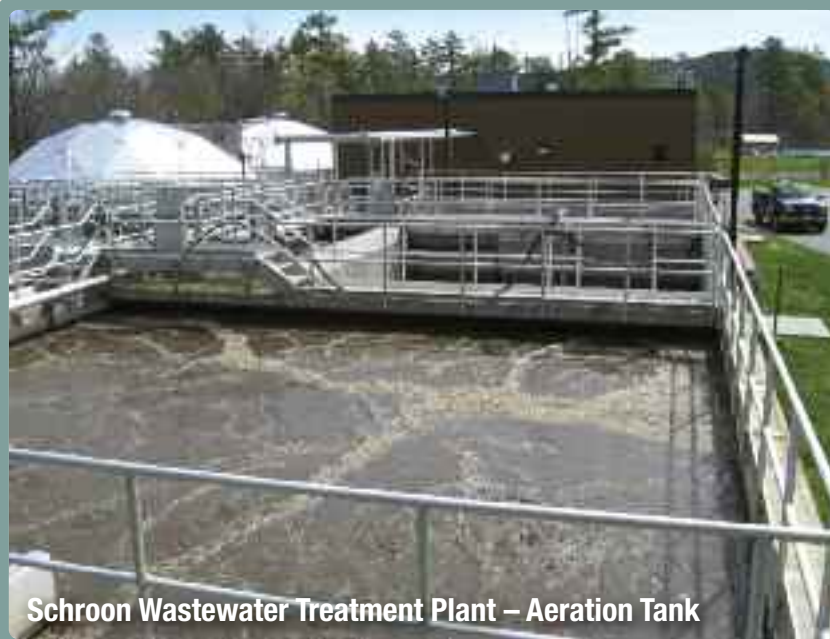
Schroon Wastewater Treatment Plant – Aeration Tank

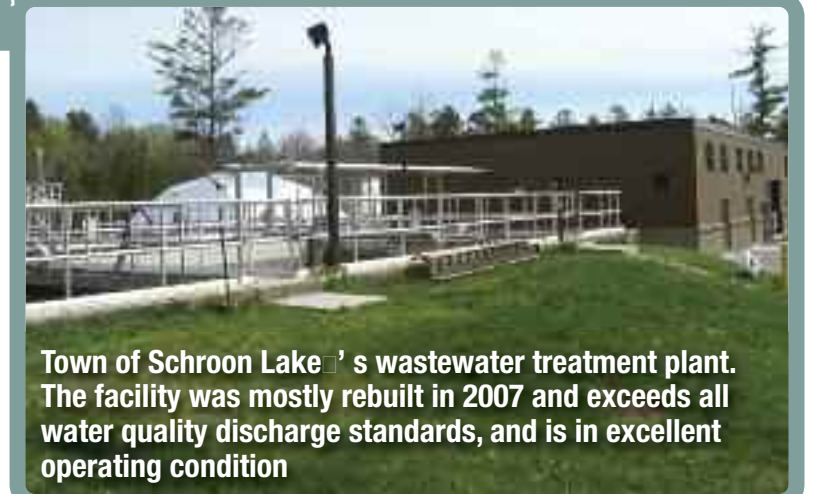
Town of Schroon Lake's wastewater treatment plant. The facility was mostly rebuilt in 2007 and exceeds all water quality discharge standards, and is in excellent operating condition

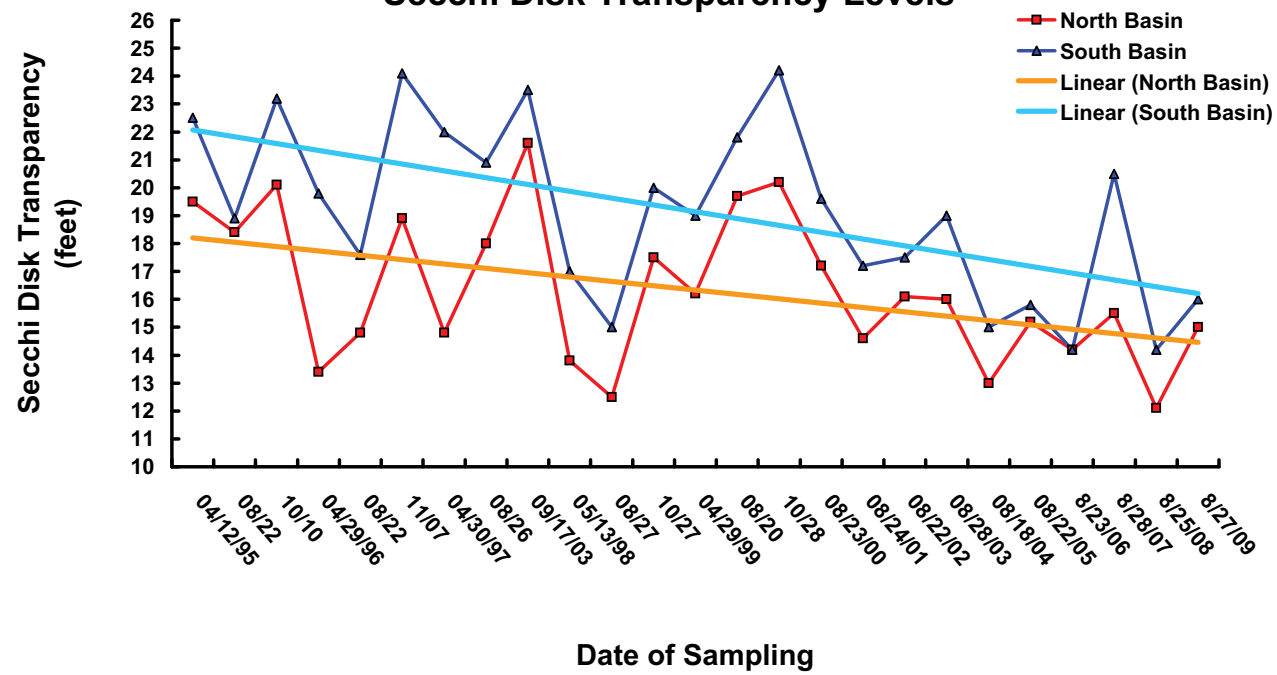
Figure 6. 1995-2009 Schroon Lake Secchi Disk Transparency Levels

Figure 6 is a comparison of historic water clarity at the two basins from 1995 to 2009. Looking at the graph, it is clear that water clarity in the south basin is consistently higher than that observed in the north basin. In fact, an analysis of the data indicates that the mid-August water clarity in the

Secchi disk transparency (SDT) readings observed in the south basin were consistently higher than those observed in the north during the month of August. North basin SDT readings averaged 15.5 feet from 1995 to 2009, while south basin readings averaged 17.5 feet during the same time period.
