Structural Assessment Schroon Lake Bandstand

August 10, 2025

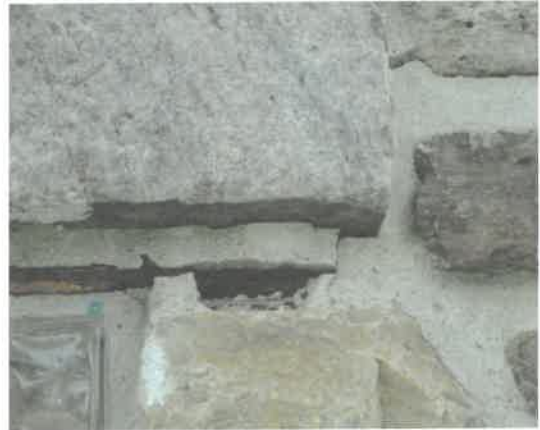
Figure 7 – West wall, Park level

- i. There are wall cracks over several openings due to rust jacking caused by corroded lintels and reinforcement. Rusted steel can expand up to nine times its original thickness, causing the mortar joint cracks. The lintels were to be repaired in 1999 to prevent the masonry from cracking further, but that wasn't done. Figures 6-9 show some heavily corroded steel lintels and the resulting wall cracks. Some of the cracks extend above to the concrete edge at the Bandstand level and have cracked that as well.

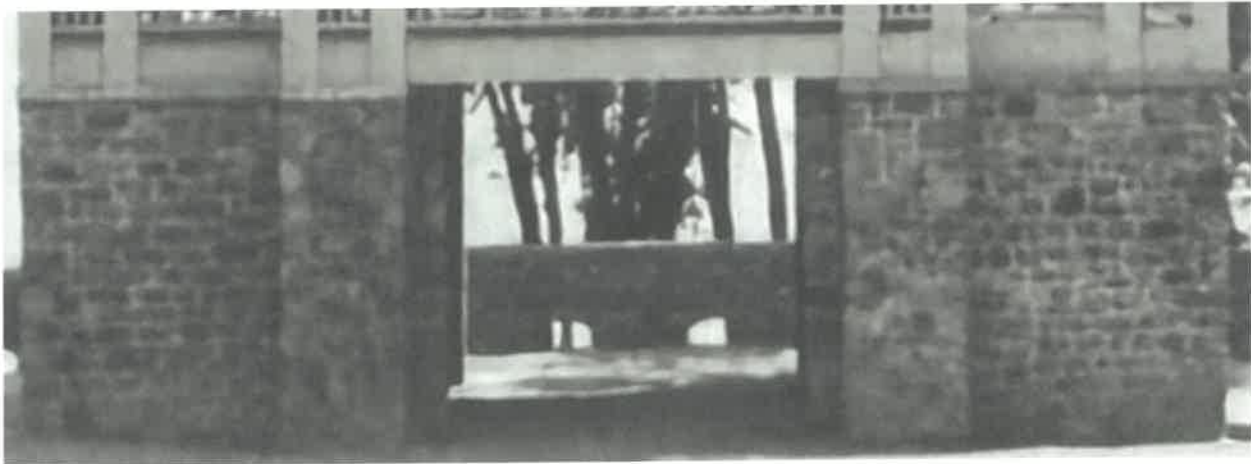
Figure 16 – Historic photograph (date unknown)

- iii. Comparing the masonry to the oldest photograph we could find for the Bandstand, it appears the masonry has been rebuilt in various areas with different stone and different patterning. Figure 15 shows an enlargement of the north wall from a historical photograph obtained from the Historical Society. Much of the stonework appears rectangular and coursed.

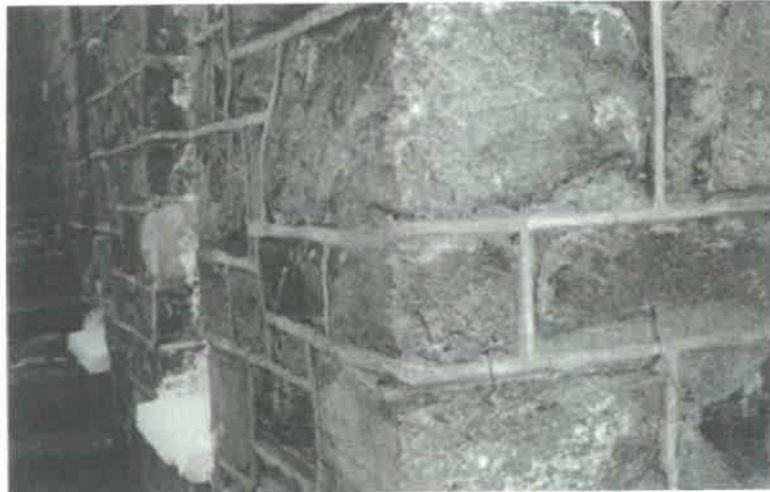
Figure 17 – Stonework before 1999 repairs

A photograph from 1999 (Figure 17) shows the masonry as rectangular coursed before the repairs. It appears stonework was significantly changed as we look at Figure 18 from 2025.

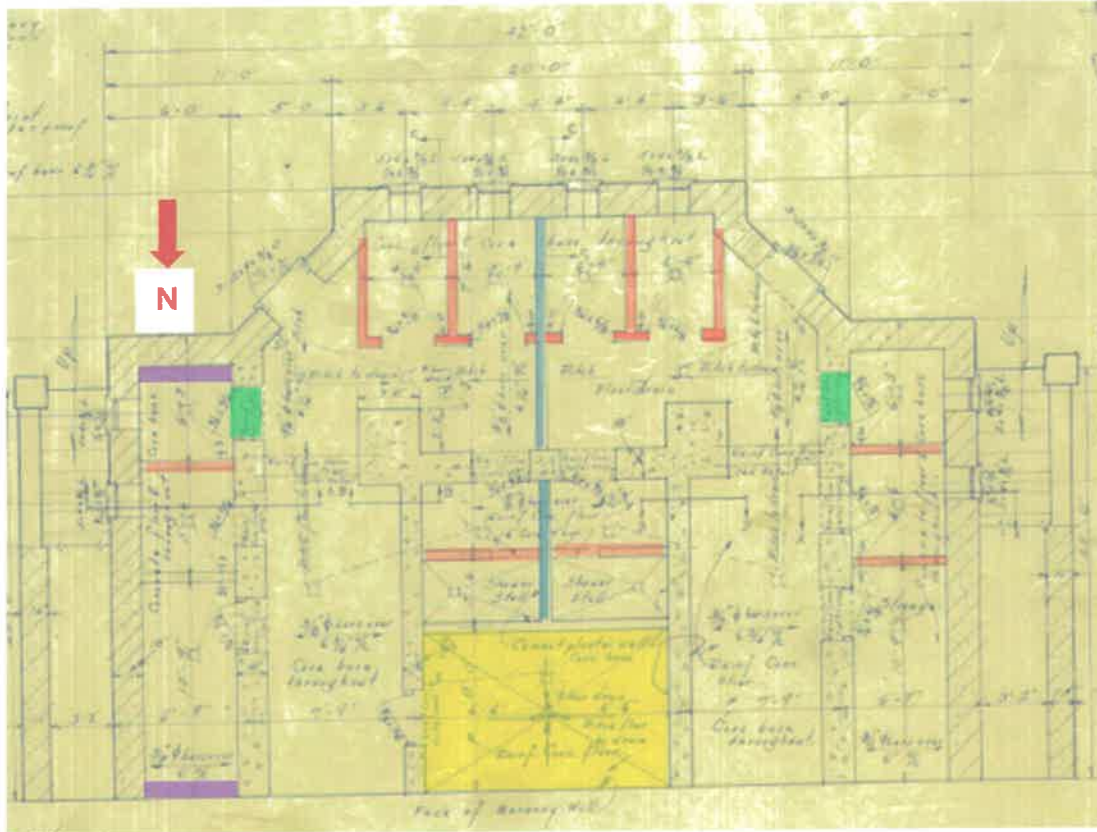
Figure 25 – Original Bathhouse floor plan

One room in the center of the north wall was shown on the original as a shower room (Figure 25, highlighted yellow). The room was to be 8 feet wide, yet it is only 6 feet. The south wall of the room was to be concrete, but is constructed of stone like the perimeter walls. All the other original interior walls are concrete.

The floor slab itself sounds hollow underneath. That is unexpected and requires further investigation and probing.

Figure 25 also shows those walls that have been removed (red), those openings that have been filled in (green), a wall that was removed and replaced with a partial-height concrete masonry wall (blue), and the two partial-height walls that were added (purple).

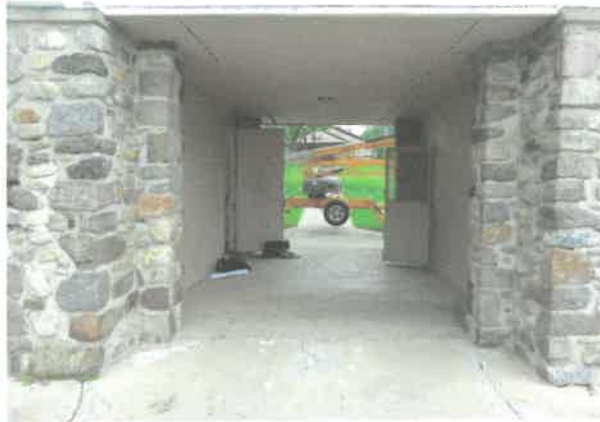
Figure 35 – Metal doors

- iii. The original drawings list the Bandstand concrete to be a 1:2:4 mix (one part Portland cement, two parts sand, four parts gravel). This was a commonly used mix in 1936 and likely produced concrete with a strength of 3,000 psi or greater.
- iv. Three wooden doors were replaced with steel in 1999 (Figure 35), and one was infilled. The doors require some maintenance.

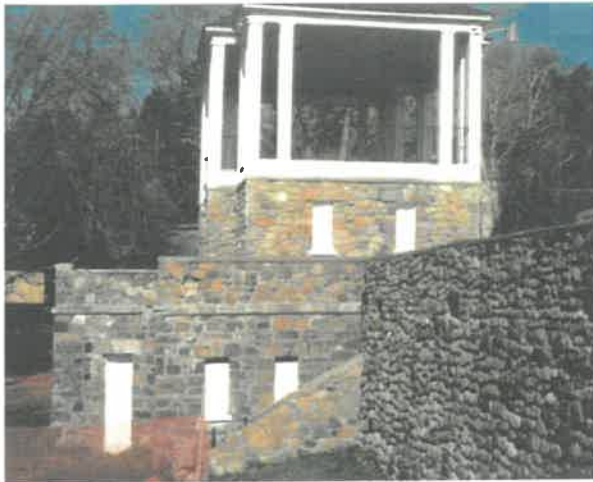
Figure 36 – 1999 Photo with windows covered

- v. The four windows at this level (two on the east and two on the west) have glass blocks like was used at the Bathhouse windows. These appeared covered in a photograph from 1999 (Figure 36) and were proposed to be infilled with masonry. There are a couple of broken glass blocks on the East wall (Figure 37). Intact blocks from the bathhouse level could be used to replace these, and the jambs can be rebuilt.

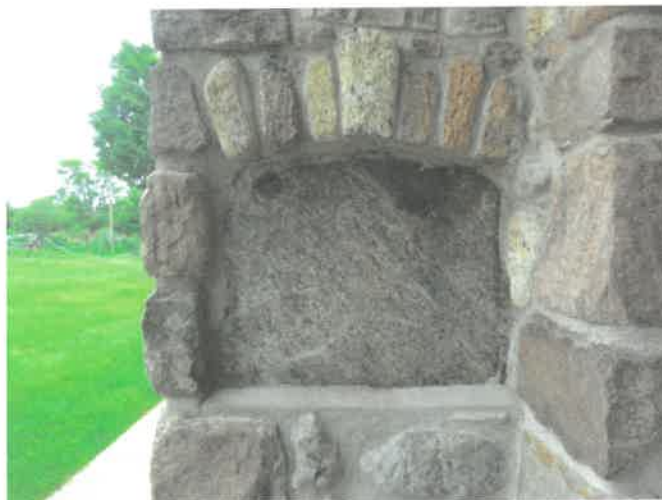
Figure 38 – Niche at entry

- vi. There is a stone niche on the east side of the entry at the Park level (Figure 38). It may have been used at one time and could be used again.

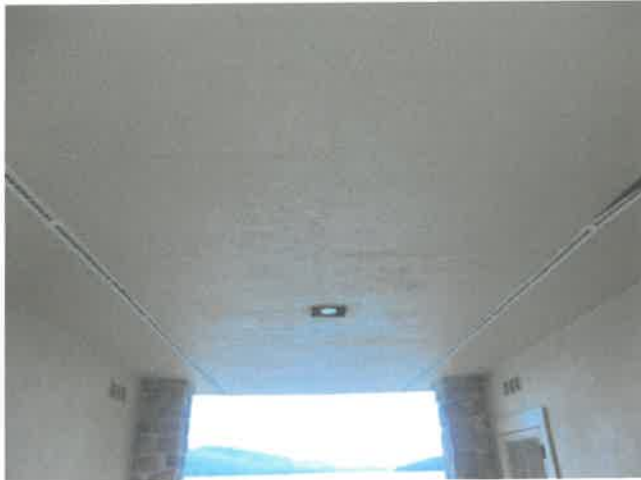
Figure 39 – Tunnel ceiling

vii. The wall covering and the ceiling for the “tunnel” were installed in 1999 (Figure 39 and are generally in good condition. Additional vents were proposed in 2007 but were not installed, and there appears to be no need for them. There has been damage to a portion of the vents (Figure 40). We did not have access above the ceiling to check the framing. The flooring above needs to be removed to check it.

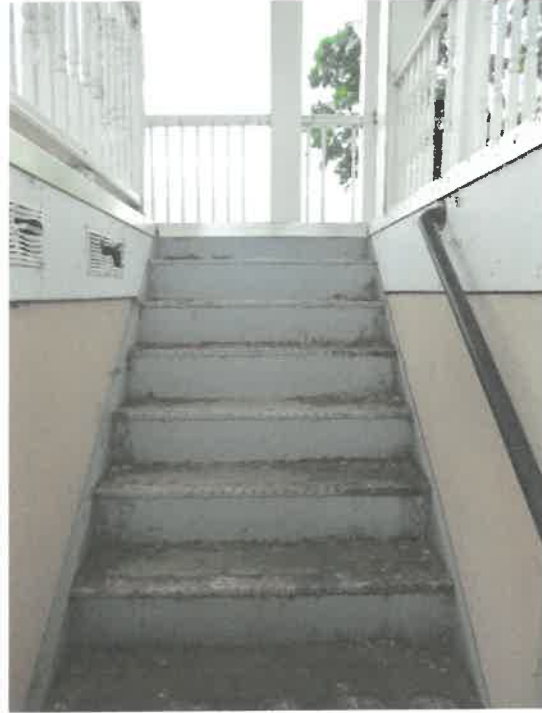
Figure 42 – Stair looking at Bandstand level

viii. The stairs to the Bandstand level were replaced in 1999 (Figures 41-43). They were to be removed, repaired, and reinstalled in 2007, but that did not occur. The Bandstand level opening allows rain, snow, leaves, birds, etc. to enter. There is no drainage; the water sits on the stairs and runs to the Park level. Figure 43 shows the corroded stair framing.

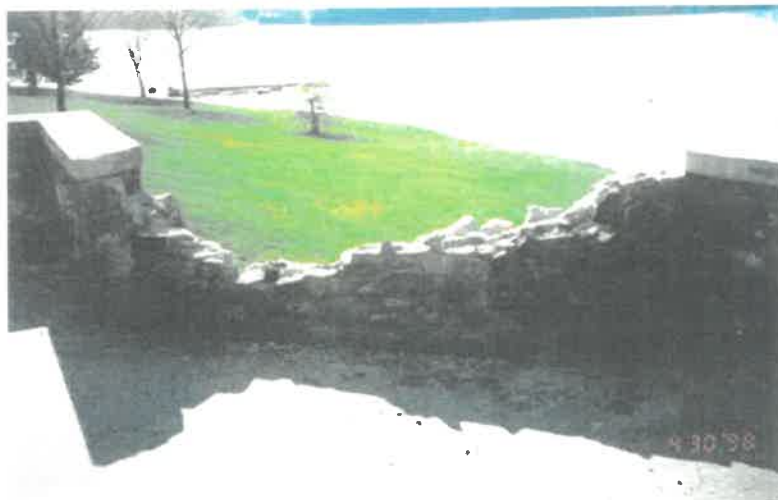
Figure 47 – 1998 Photograph of Terrace railing with concrete cap

- x. The Terrace railing wall was taken down and rebuilt in 1999 with a concrete cap. The cap was originally stone, but in a 1998 photograph (Figure 47), it was concrete.

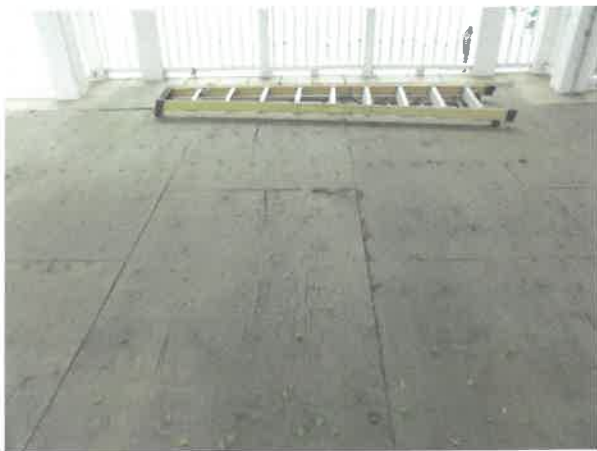
Figure 51 – Center of Bandstand floor

- ii. The Bandstand floor has no drainage and no protective flooring; weathering has deteriorated the plywood deck. The center span of joists needs strengthening. The notched joists need reinforcement.
The flooring proposed in 1999 was an epoxy coating over plywood. In 2007, the proposal was for vinyl flooring.
The problems to be overcome include:

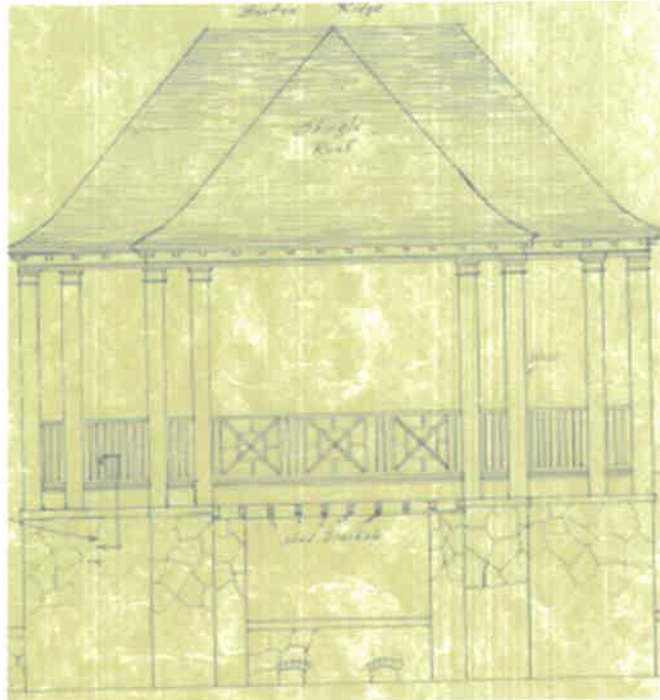
Figure 53 – Wood railing from 1936

In both 1999 and 2007, the railing was recommended to be replaced with an aluminum railing. At some point, it was replaced with plastic, not aluminum. It does not match the original design, and it is not safe, particularly at the stair opening (Figure 50).

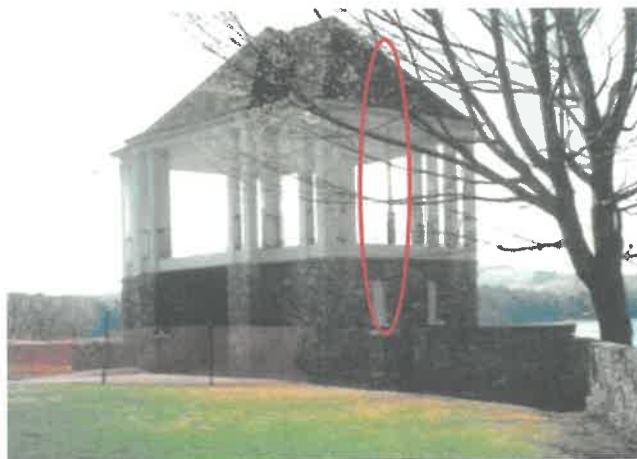
Figure 54 – 1998 Photograph showing a post near the stairs

A photograph from 1998 (Figure 54, oval) shows a post that appears to be near the stairs. This may have been to brace the railing around the opening and/or contained a plumbing stack from the toilets below. Apparently, it was removed in 1999.

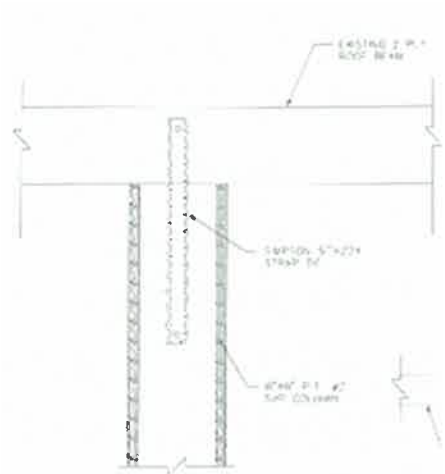
Figure 56 – From 2007 Design

Ethan Thompson and crew removed one of the column post covers (Figure 55, arrow). Figure 56 shows the 2007 detail, which had a 2-inch wide 24-inch-long strap. There was no strap connector found (Figure 57).

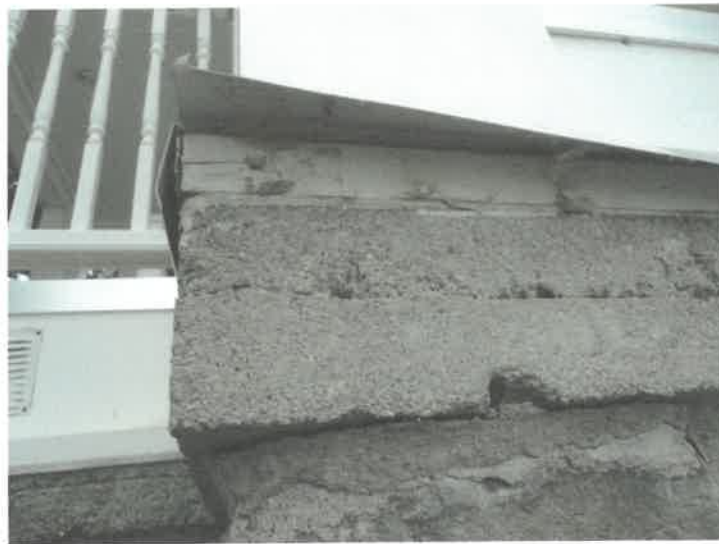
Figure 58 – Concrete cap on masonry pier with wood on top

Figure 58 shows the concrete at the top of a masonry pier supporting a column. The wood was not detailed on the original drawings, nor was the connection from the column.

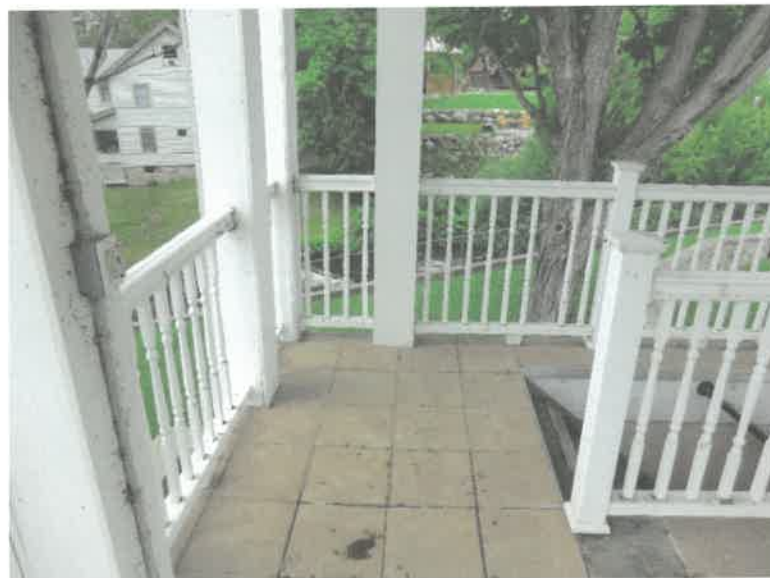
Figure 60 – Insects on columns

- vi. The ceiling and columns appear in generally good condition except for an insect infestation (Figure 59).

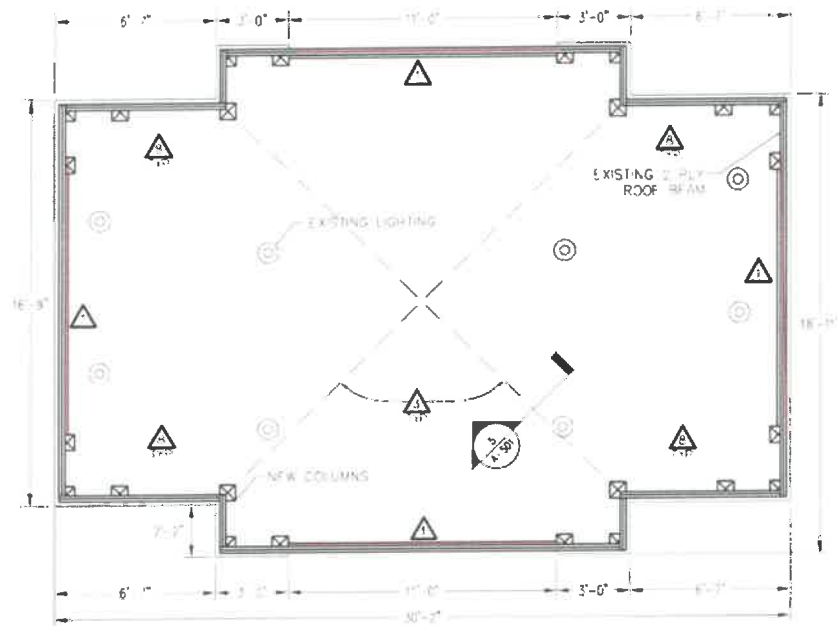
Figure 61 – Roof Plan from 2007 Repairs

- i. The roof framing above the ceiling is in good condition overall. The 2007 recommendations proposed strengthening the valley rafters and adding four beams to the existing (see red lines for the four proposed beams on Figure 61).

From inside the attic, the notched top of a new column was visible as well as the original 2 -2x10 roof beams (red arrow and yellow arrow respectively (Figure 62). Thus, the 2007 proposed beams were not added. We agree they should be added as shown on Figure 61.

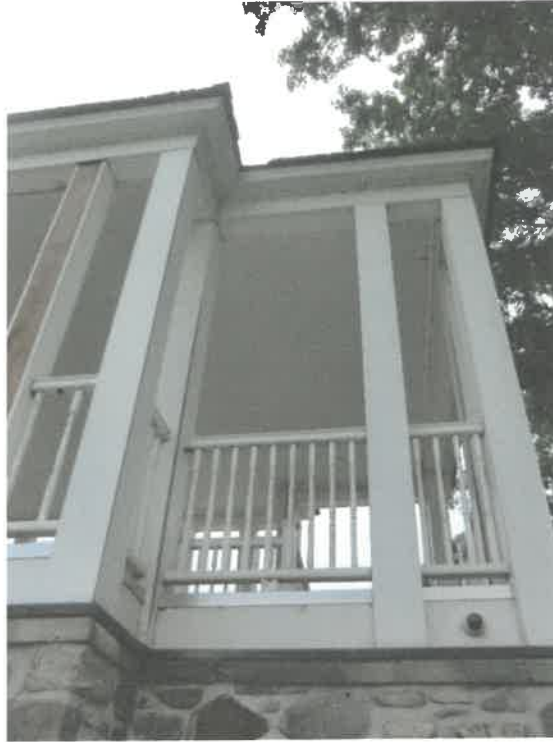
Figure 63 – Existing beams and columns without ornamentation

- ii. The original exterior trim work that was original to the bandstand has nearly been stripped away. In its place, there is a synthetic (plastic) material that covers the columns and beams. This synthetic material is low maintenance, but it leaves the

surfaces flat without ornamentation (Figure 63), whereas the original drawings show some ornamentation of the columns with caps; the north, east, and west roof beams with medallions; and ornamental brackets on the north and south floor beams (Figures 64-66).

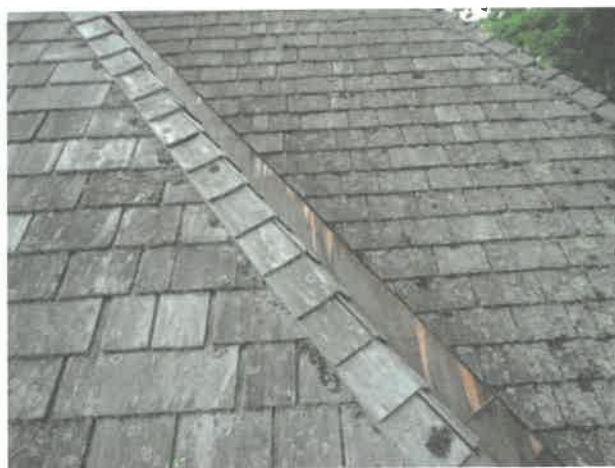
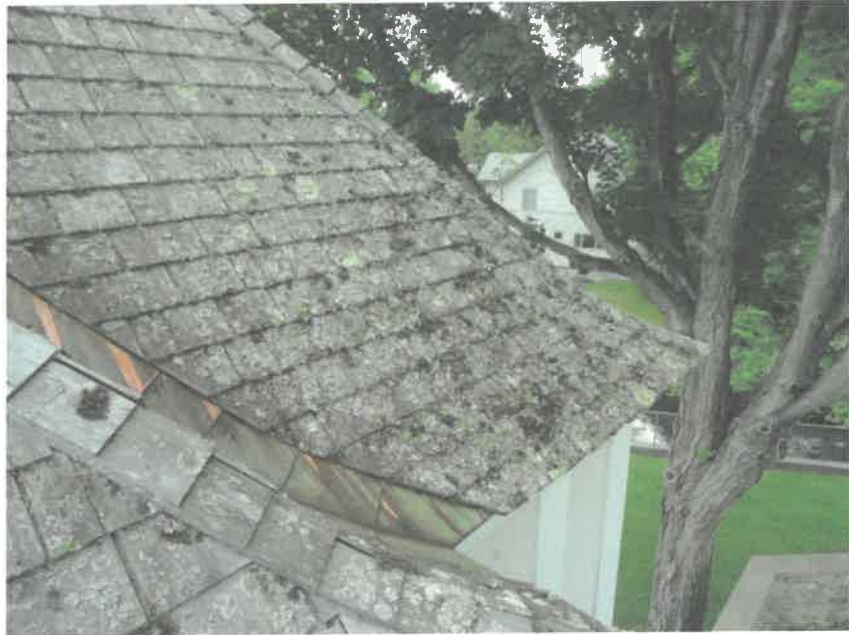
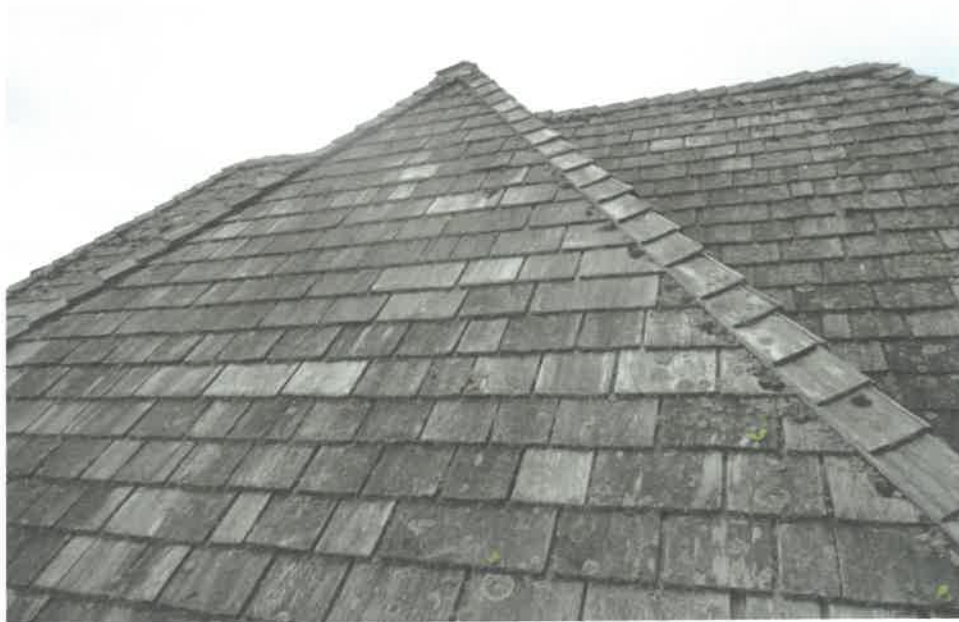
- iii. The original shingle roofing was replaced with wood shingles (Figures 67-69). Much of the roof is covered with moss due to the adjacent tree. The valleys have copper flashing.

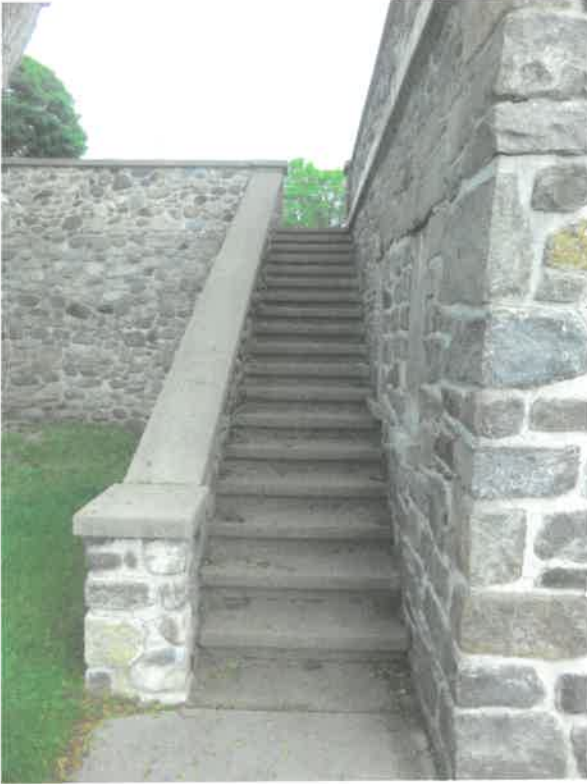
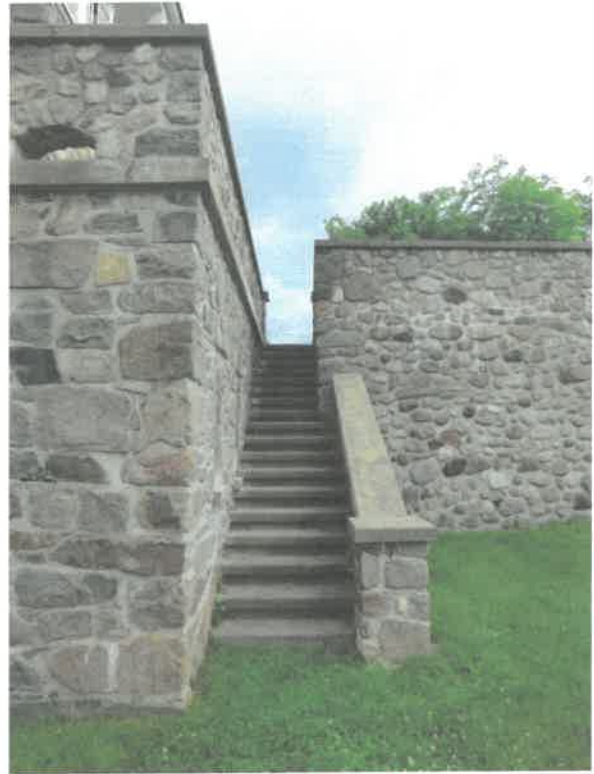
- iv. The stairs to the Bathhouse level on the east and west were replaced in 1999 (Figures 74-76). Figure 76 shows a minor crack and separation at the west wall.

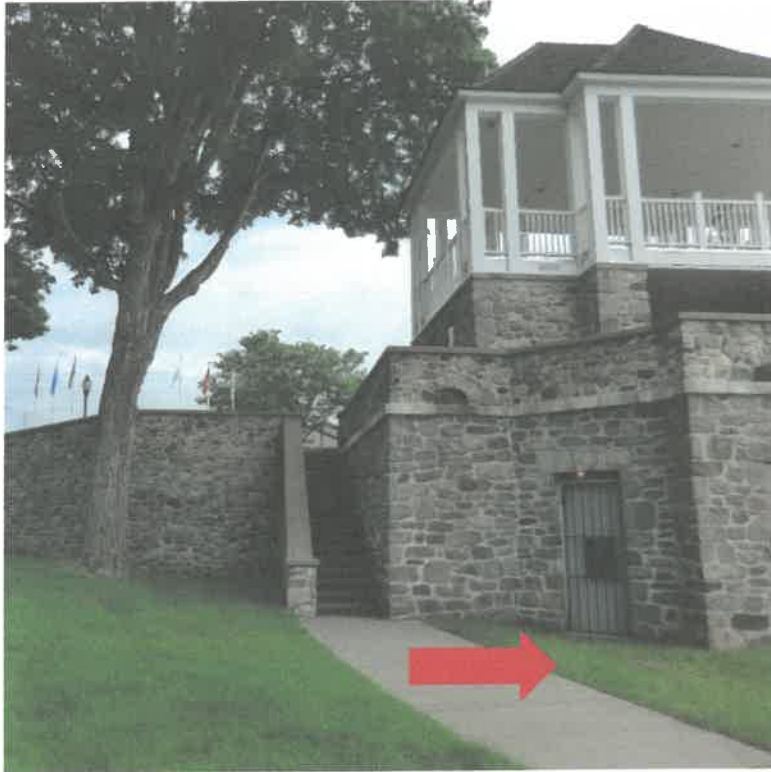
Figure 77 – Tree roots adjacent to building

- v. There are exposed tree roots near the southwest corner (Figure 77, arrow). These could be causing some of the wall and slab settlement in the Bathhouse. The photograph also shows the tree overhanging the roof.
